# Real Estate Inspection Report

February 07, 2009.

**1912 N St Andrews Place  
Hollywood, CA 90068**

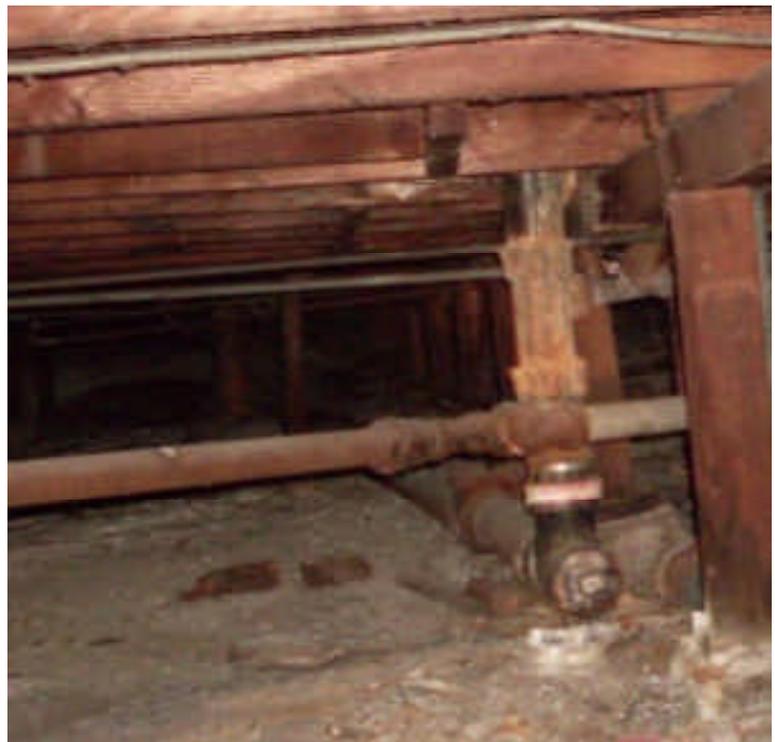
Needs Attention, there are rusty areas on the exterior of the waste lines. It is not possible to tell when but they will need replacing in the future as they continue to wear out.

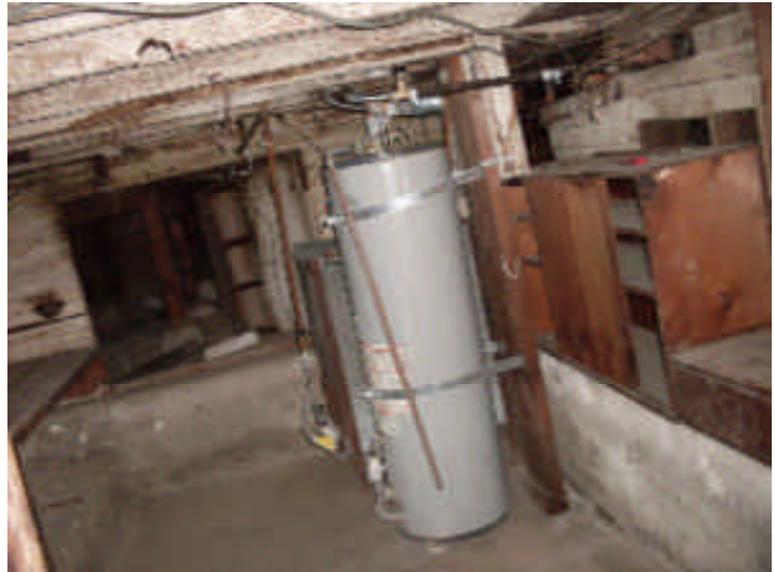
The water heater is located in the basement.

CONDITION: Serviceable appearing, though the gas is off to the property so the water heater could not be fully tested and its condition is unknown at this time .

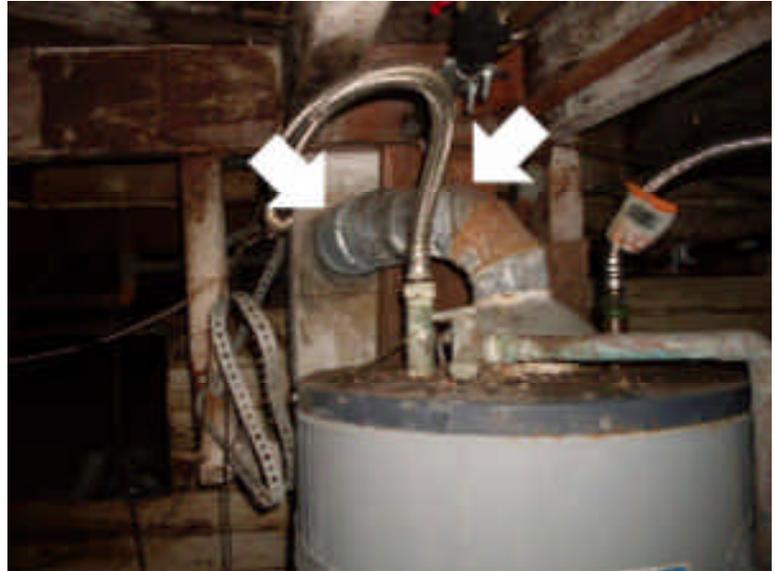
Needs Attention, the vent line from the water heater has a negative fall and the gases will not vent properly. This is a safety hazard and needs to be repaired.

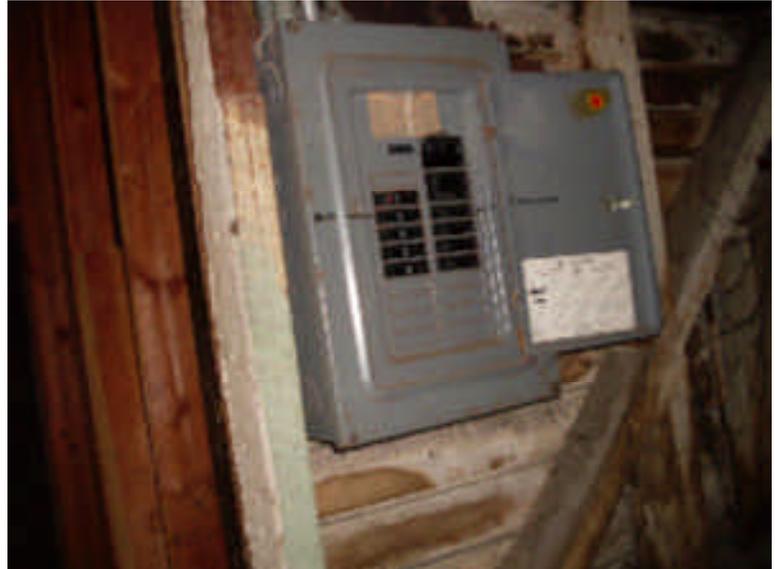
There is a panel seen in the basement which is an upgraded panel.

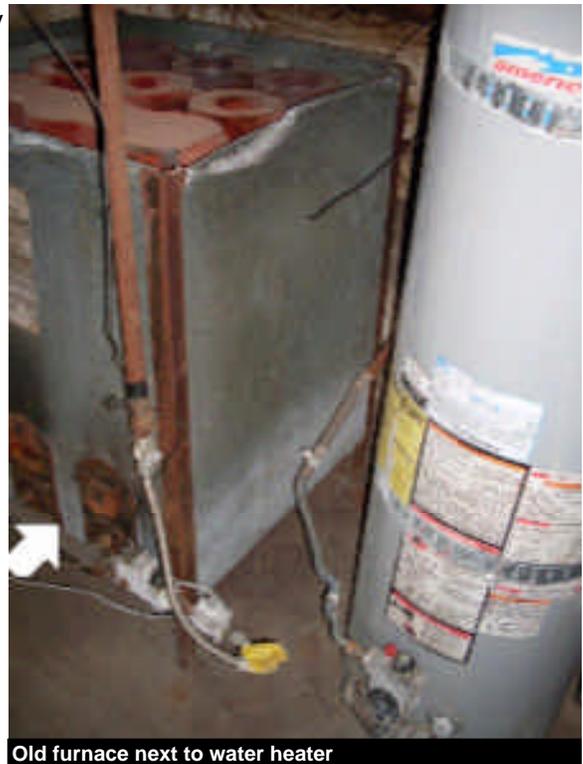
**CONDITION:** **Not Acceptable**, the very old unit has been dismantled and all of the ducting removed and is not operating.

An entire new heating would be required to make this habitable.

**COMMENTS:** It is advised to have a licensed heating contractor examine the heating system and make all needed repairs/replacements to ensure a safe and properly operating system. It is expected that the heating specialist may find additional items that need repair as the general inspection is designed to turn it over to them when problems show up in a system so it can be further investigated.

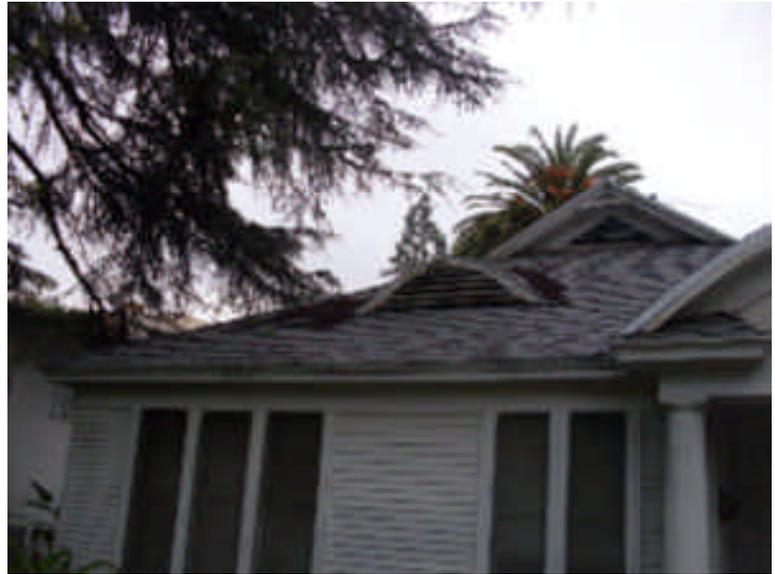
It was reported that the roof is about ten years old. There are obvious signs of neglect and excessive vegetation on the roof. There are no gutters and poor drainage control.

There is rotted wood along the roof eaves in many areas especially in the back right side.

COMMENTS: There are some repairs and maintenance seen to be needed to correct the roof and extend its life. A licensed roofing contractor should examine the roof and make all needed repairs (or replacements) to ensure a long lasting leak free condition. The roofing contractor may find more problems with the roof and this is why it is being referred to a specialist so they can determine all the problems and give an accurate estimate of the costs involved.

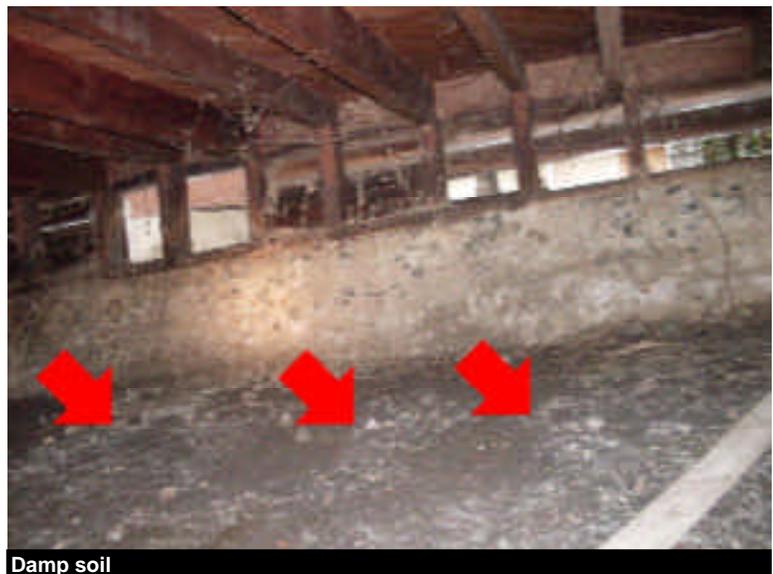
**Not Acceptable**, there are areas of excessive dampness in the soil under the building. This may cause the building to feel damp and create the growth of mold and/or mildew. It is typically advised to have this examined by specialists to have the source of the moisture detected and any needed corrections performed plus any growth properly abated.

Water and moisture intrusion is seen entering especially in the back left area.

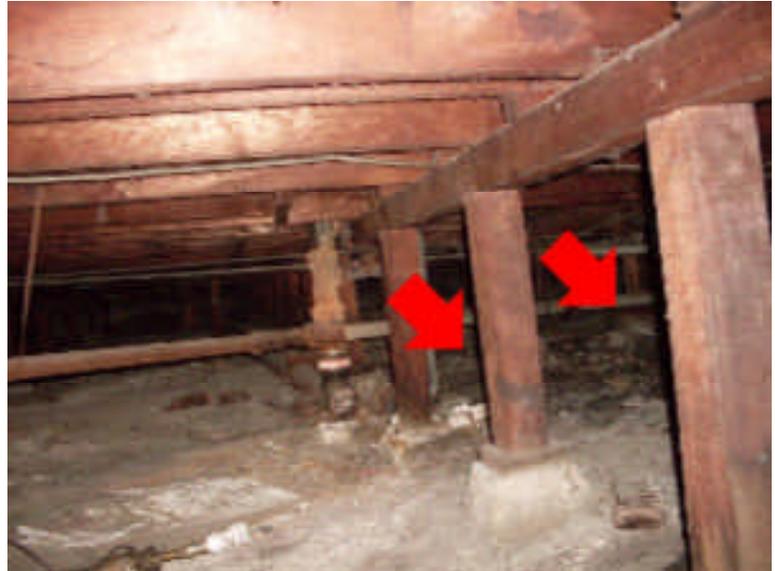
The middle right area shows damp soil.

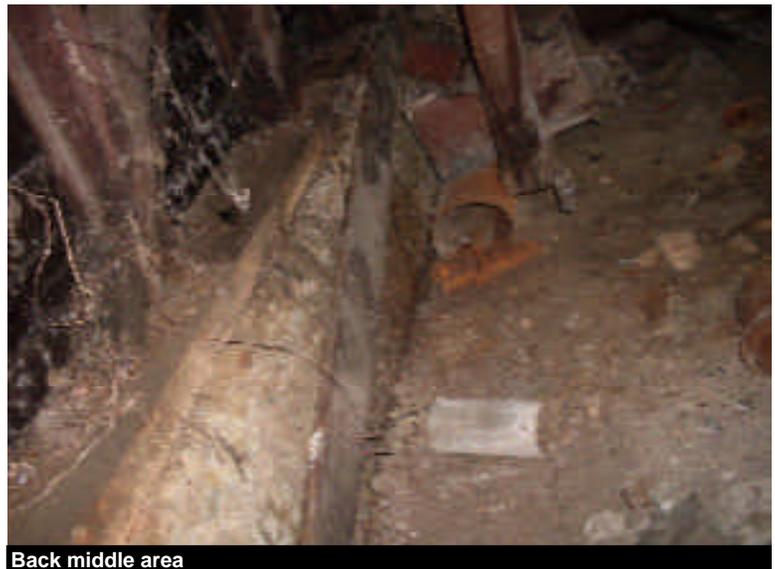
Back middle area

Needs Attention, The structure is not bolted to the foundation. Ideally foundation anchor bolts would be added to attach the wood frame of the building to the foundation to prevent movement in case of seismic activity.

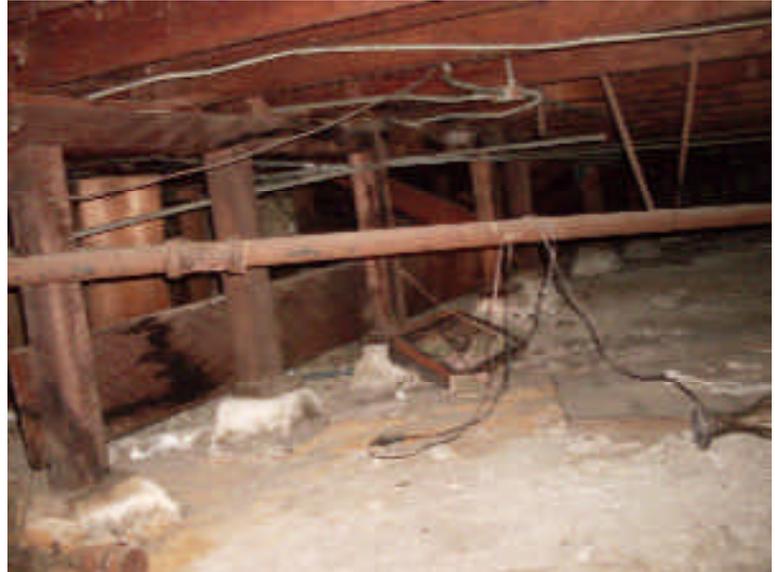
Needs Attention, the posts in the middle area have shifted and are out of plumb a little.

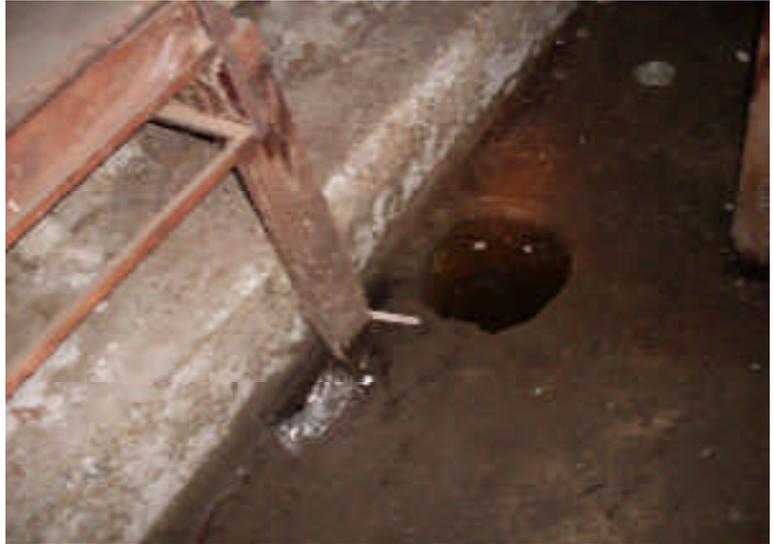
**sump pump well full of water**

**Not Acceptable**, there is water percolating up at the floor and concrete wall and water is ponding on the floor.

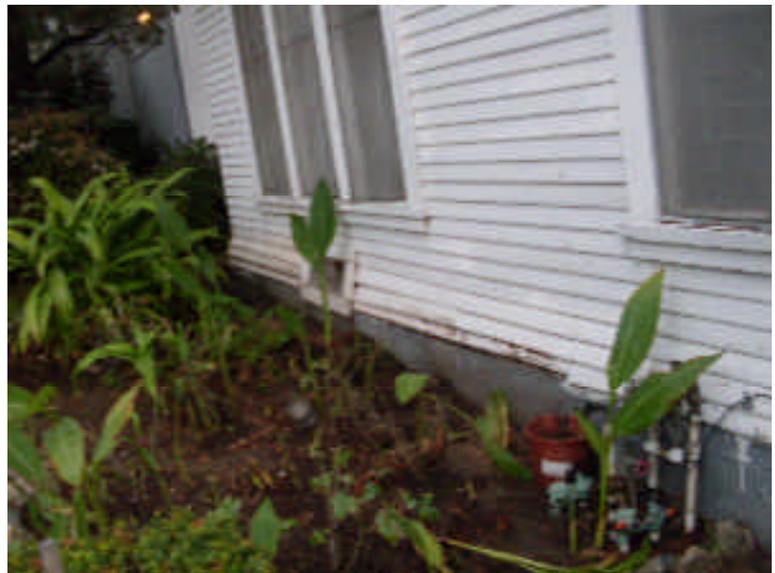
Needs Attention, there is rotted wood in several areas such as along the bottom siding on the left side, see the pest control report for more information.

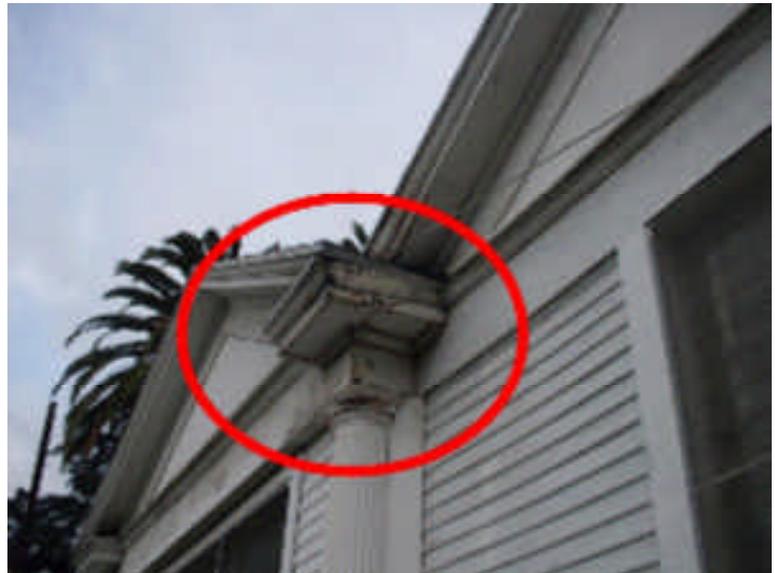
**Not Acceptable**, the trim has areas of damage such as on the right back side.

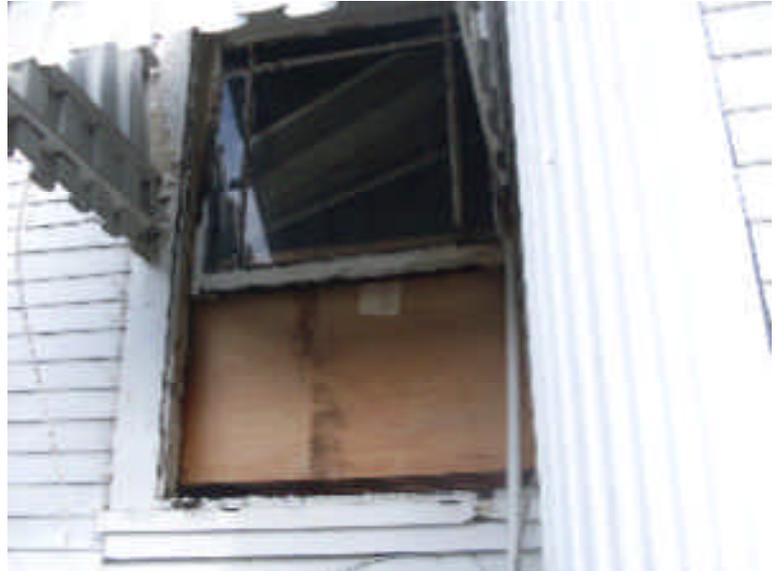
The awning over the right window near the enclosed porch appears to have re directed the water run off onto the column area, the wood is damaged and there are moisture stains in the corner inside

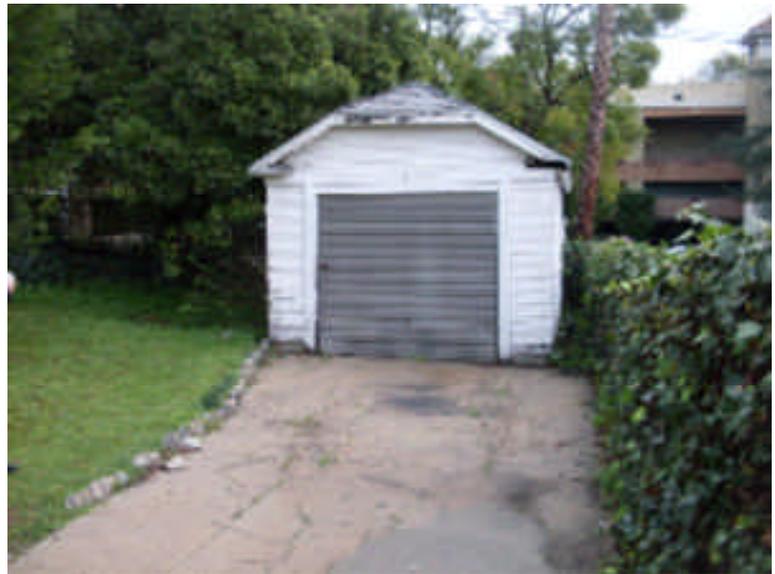
The interior was not entered and inspected but the overall condition appears to be in functional condition with no leaning walls and typical wear and peeling paint on the exterior.

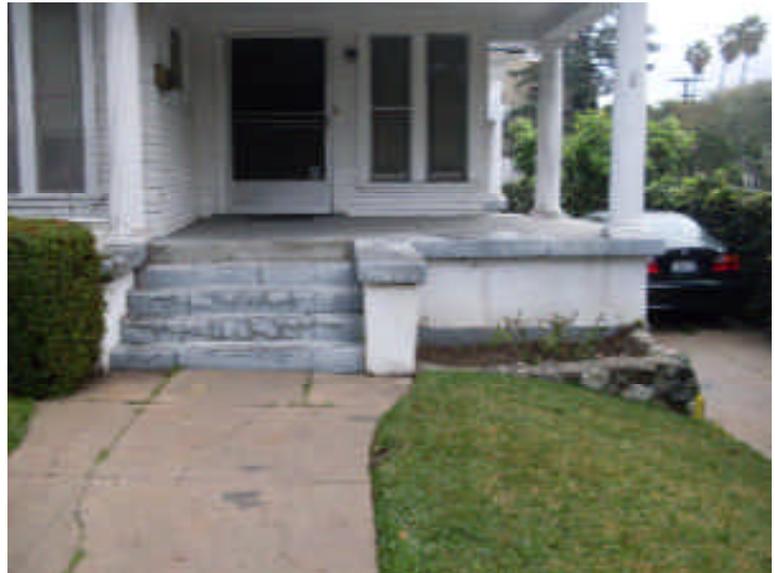
Serviceable.

Note: the front porch does not show any obvious cracks or settling and appears to be in better than average condition relative to its age.

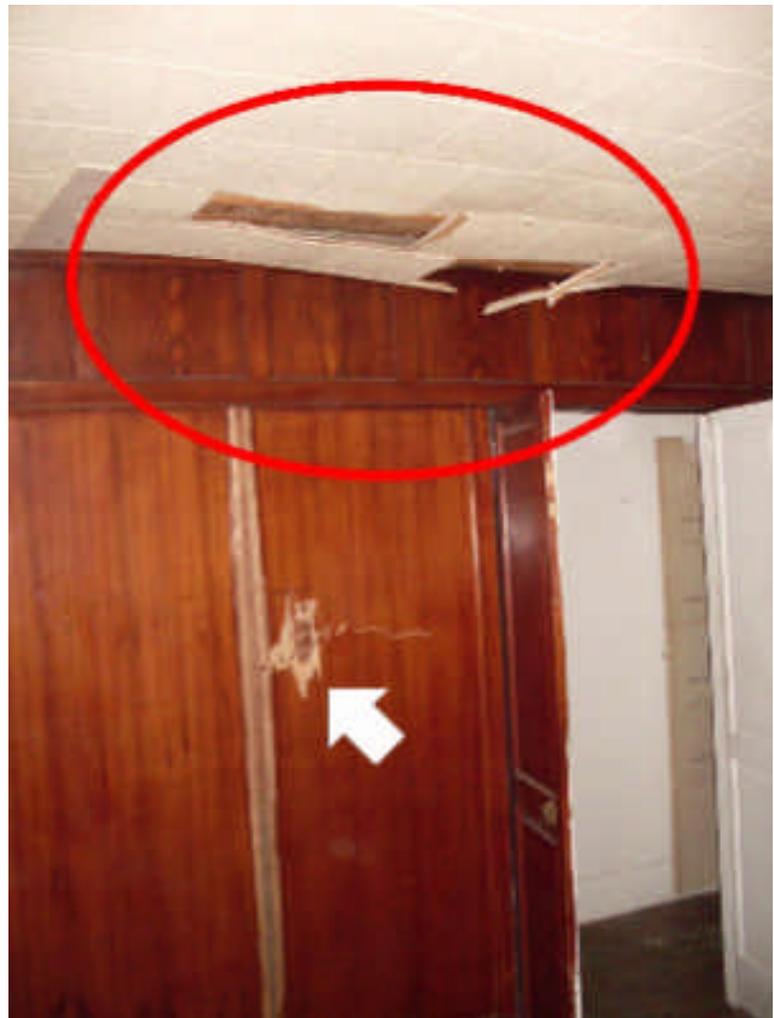
Needs Attention, there are areas of damage to the wall and ceiling.

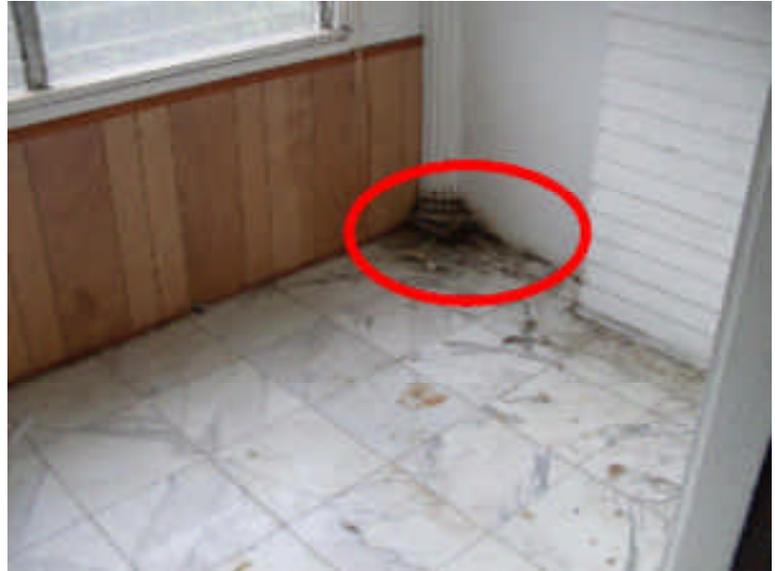
Needs Attention, there are areas of moisture stains, on the wall and bottom corner (the window with the awning is just outside of this area)

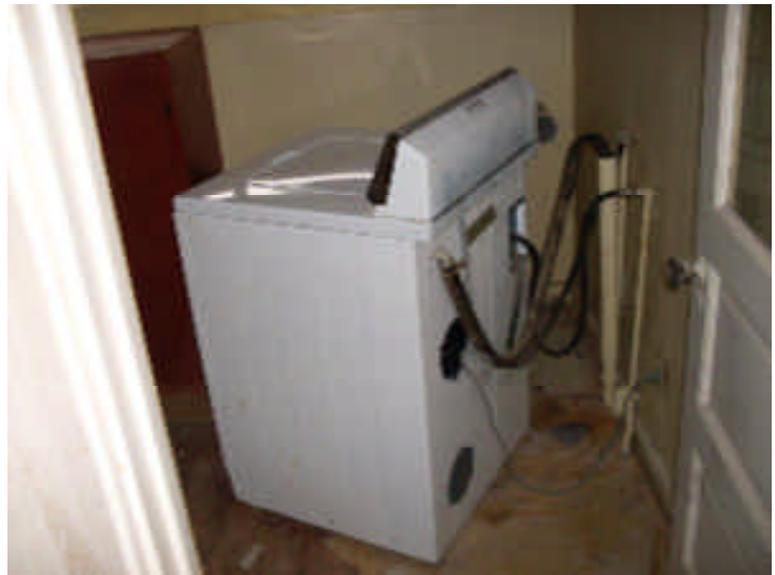
Hook ups are present but deferred maintenance.

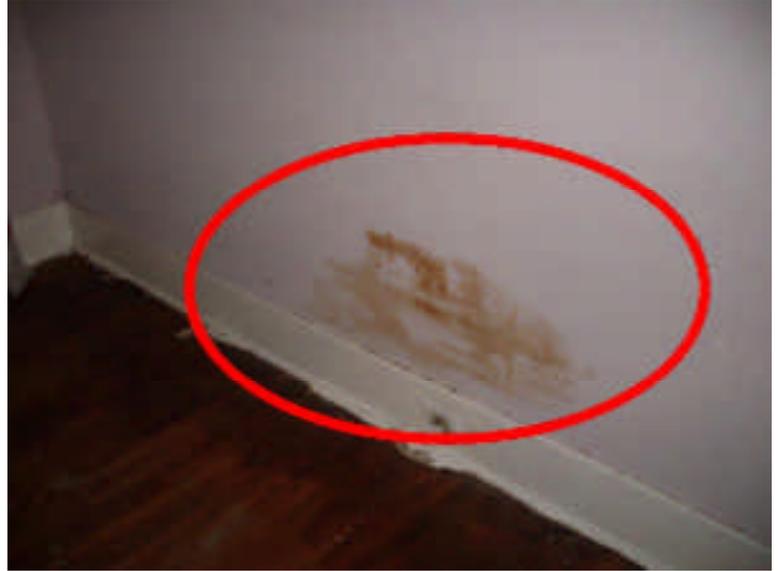
Needs Attention (front bedroom), there are areas of moisture stains, on the wall which is on the other side of the bath room sink.

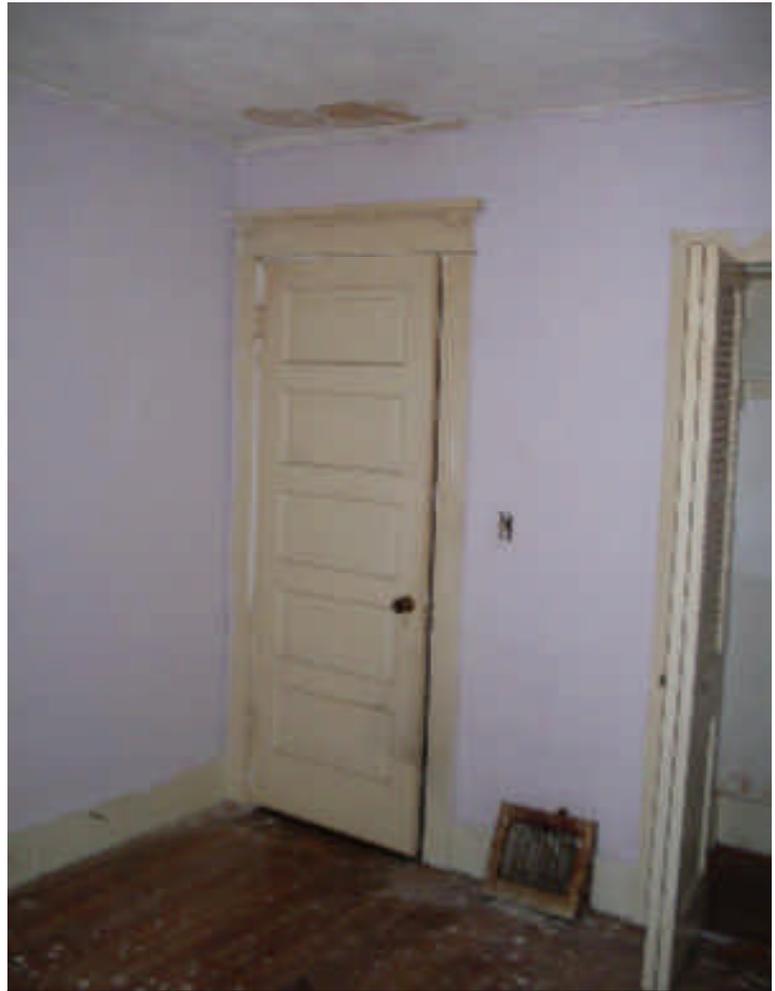
**Back bedroom door out of square**

There are areas where the flooring is sloping and not level and slightly uneven indicating some settlement has occurred. The floors are not level and the windows and door frames may not be plumb. see the Foundation section of this report for more information.

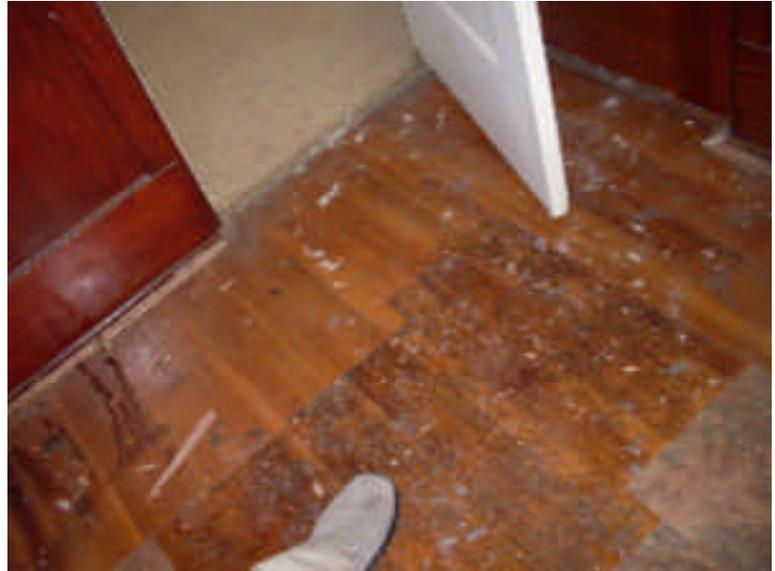
Uneven floor in back dining room hall area.

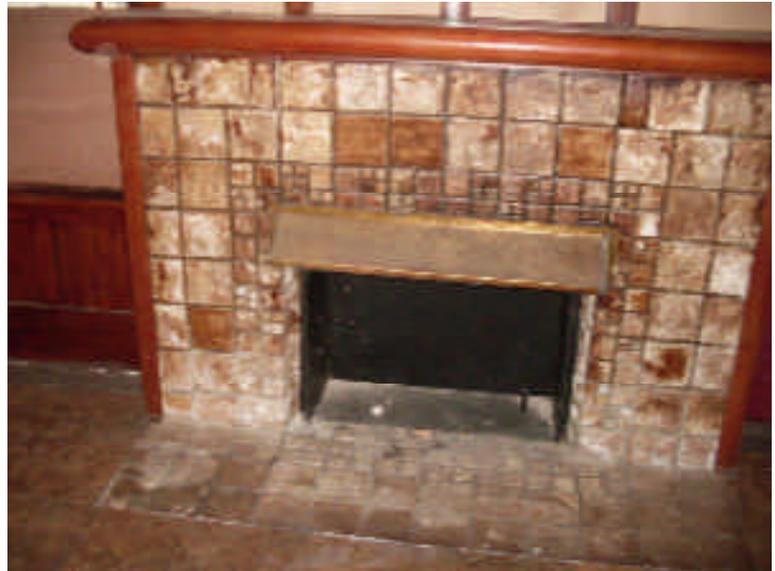
Living room.

This appears to be an older design which had a gas heater type unit placed in the opening. This has been removed.

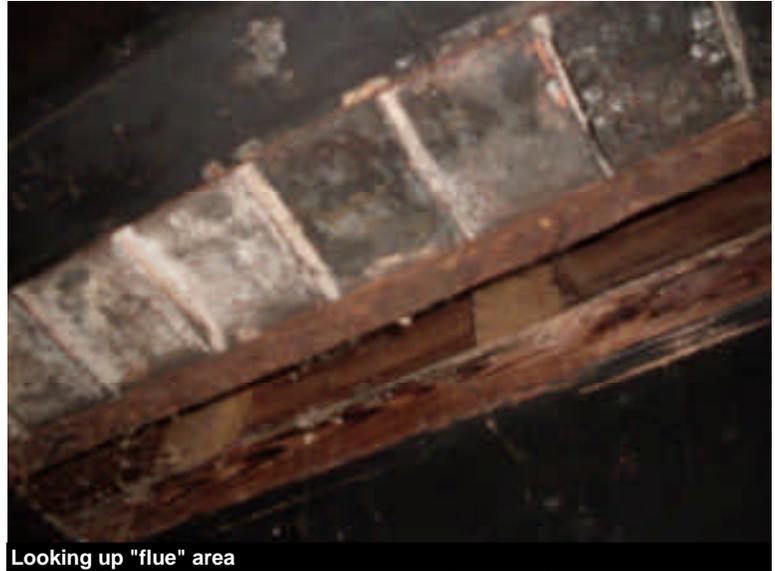
**Not Acceptable:** , the flue vent pipe has been removed and this can not be used and would require extensive work to modify and install a new gas appliance system.

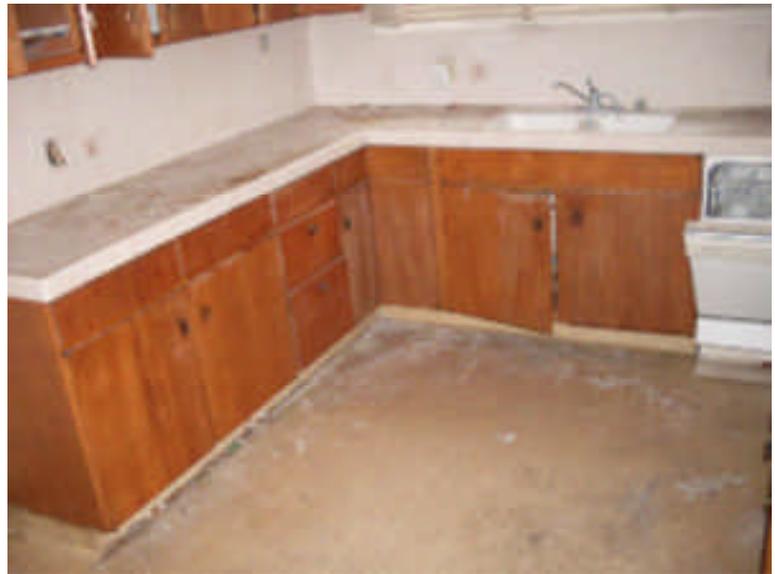
This is in general deferred maintenance but appears to have been functional in the recent past.

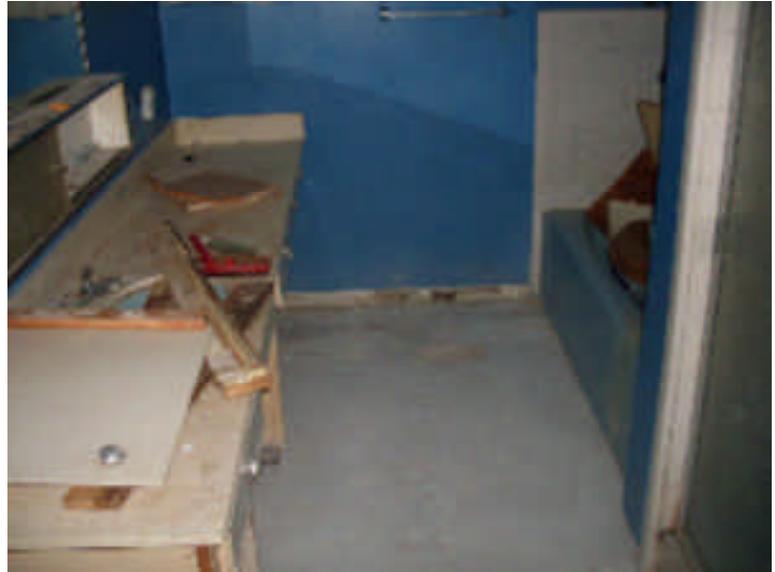
The toilet has been removed, and there is debris from partial demolition of the sink and cabinets and the tub is filled with debris.

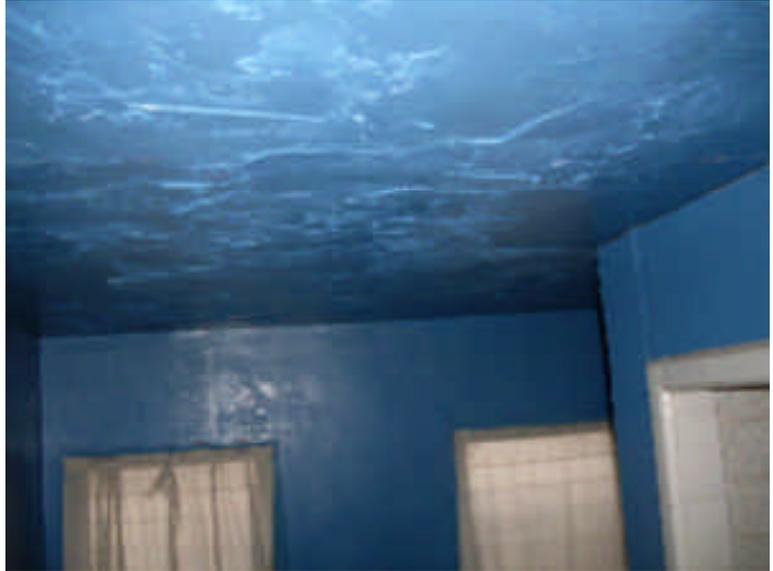
The blue painted ceiling appears to be in serviceable condition.
